## **Human and Natural Factors in the Deterioration of Indigenous Irrigation Furrows in Marakwet, Kenya**

*This paper examines factors influencing deterioration of Marakwet irrigation furrows drawn from Embobut River, Kenya. The furrows are located at 1°12'N to 1°15' N and 35° 35' E to 35° 40'E and flow along Sibow, Sagat and Kapchubai Escarpments to crop fields in the Kerio Valley. In total, there are fourteen furrows tapped from the upper and lower part of the perennial river. They were constructed with inferior materials such as wood, leaves, grass and mud. Today, a number of the structures are broken, leaking, silted, eroded and blocked by mud and rock debris and no longer efficient in their function as in the past. Both climatic and human factors have contributed to decay of the systems.*

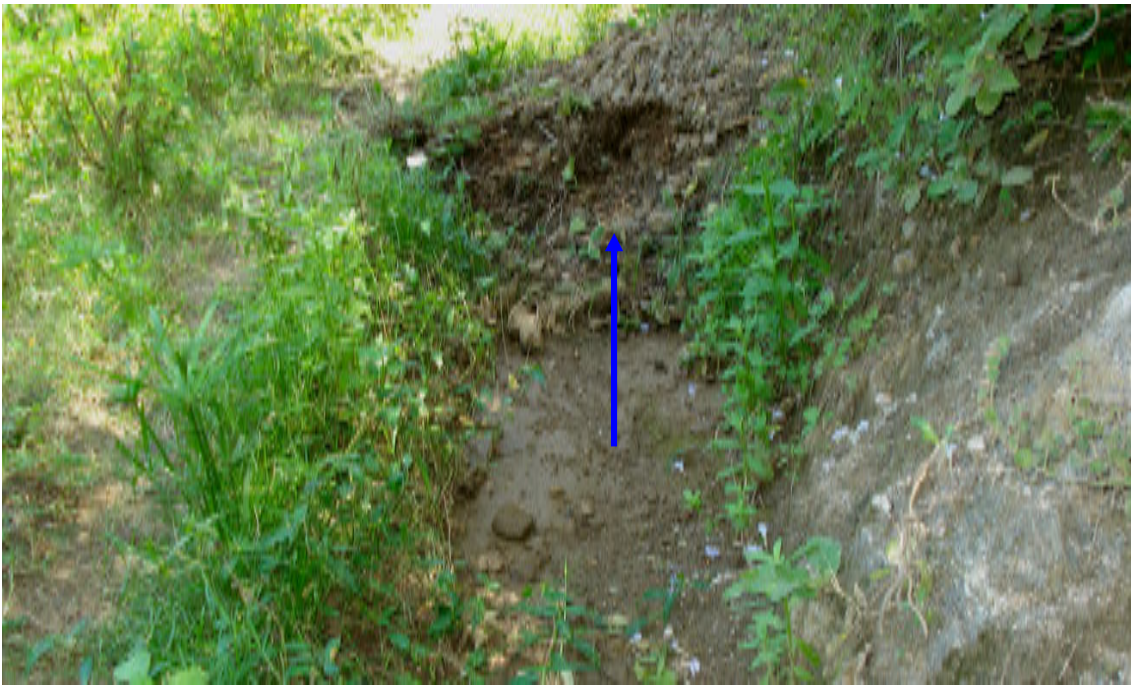
The run-offs also trigger mudslides which block the furrows and disrupts the flow of water. Observation of the Kasukut furrow in Barkelat Sub-Location for example, showed blockage of the furrow by mud from heavy rains of October 2008 (Plate 1). In the focus group discussion in the five sub-locations studied, it emerged that rain cause severe flooding which then erodes the soils, causes mud slides and uproots trees along furrow embankments leading to breakage, erosion, siltation and overflows of furrow structures. Run-off also dislocates furrow intakes. The intakes are built of wood and small stones which do not withstand the flooding of the river during rainy seasons. The research concurs with the findings by Soper (1982) on the survey of the Marakwet irrigation systems which had similar findings.

**Plate 1 Blockage of the Kasukut Furrow by Mudslides**

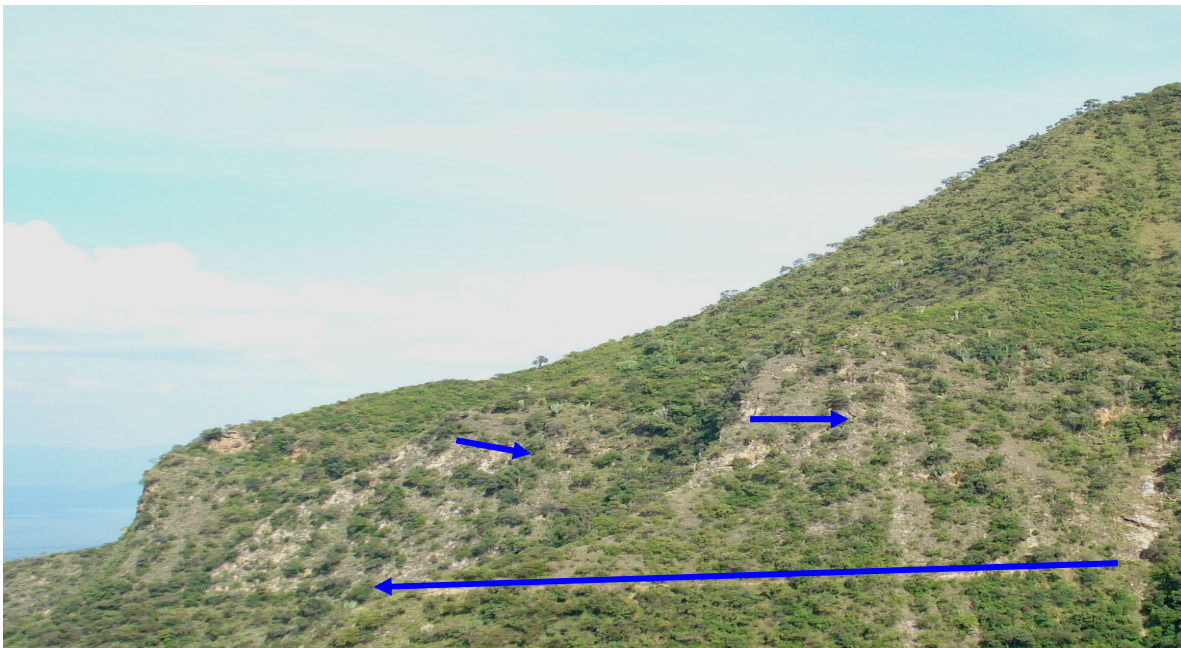
The key informants and group discussions pointed at environmental degradation such as deforestation and soil erosion in the division as the main factor influencing deterioration of the furrows. Marakwet community over-exploit the escarpment areas for local resources such as poles, building stones and thatch grass. This has in turn transformed the areas into bare grounds, hence increased run-offs and damage to the furrows. Observations made on the Kapchubai escarpment, where furrows flow, show that the area is severely degraded from overexploitation of thatch grass and poles (Plate 2).

**Plate 2 Ecological Degradation of the Kapchubai Escarpment**

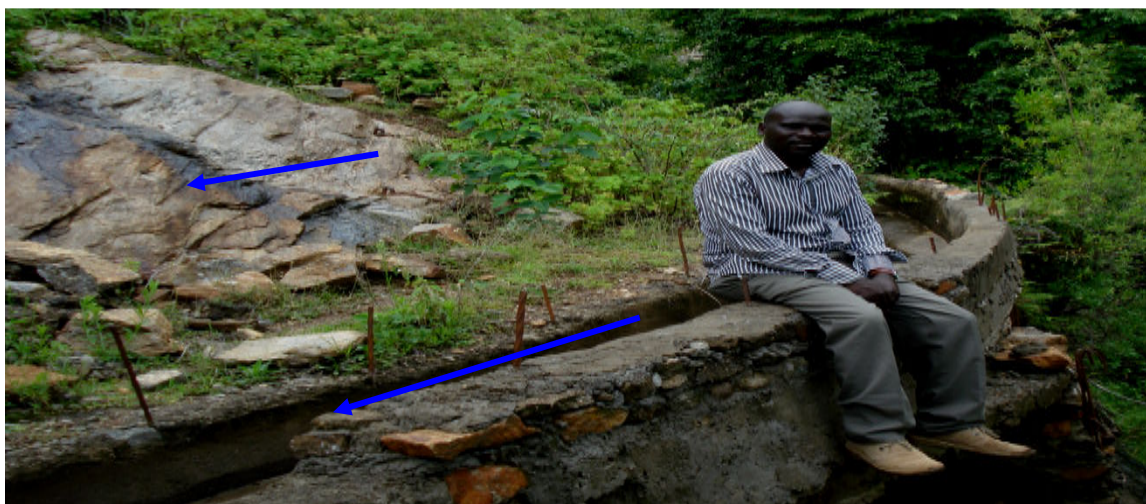
Quarrying has also contributed to the deterioration of the furrows. The stones quarried are of basalt and trachite lava and are extracted using mattocks and iron anvils into the required sizes. The materials are used in the construction of modern iron-roofed houses, churches, schools, shops and the repair of the furrows. This explains the high exploitation of building stones in the division as shown in plate 3.

The study showed more stones are being used for the repair of the furrows as compared to the past years and this has contributed to the degradation of the areas and consequently to the deterioration of the furrows. Observation made on the Kapsyoi furrow shows an increased use of the stones for the repair of the furrows and it has in turn degraded the furrow lines (Plate 3).

**Plate 3 Quarrying along the Kapsyoi Furrow**

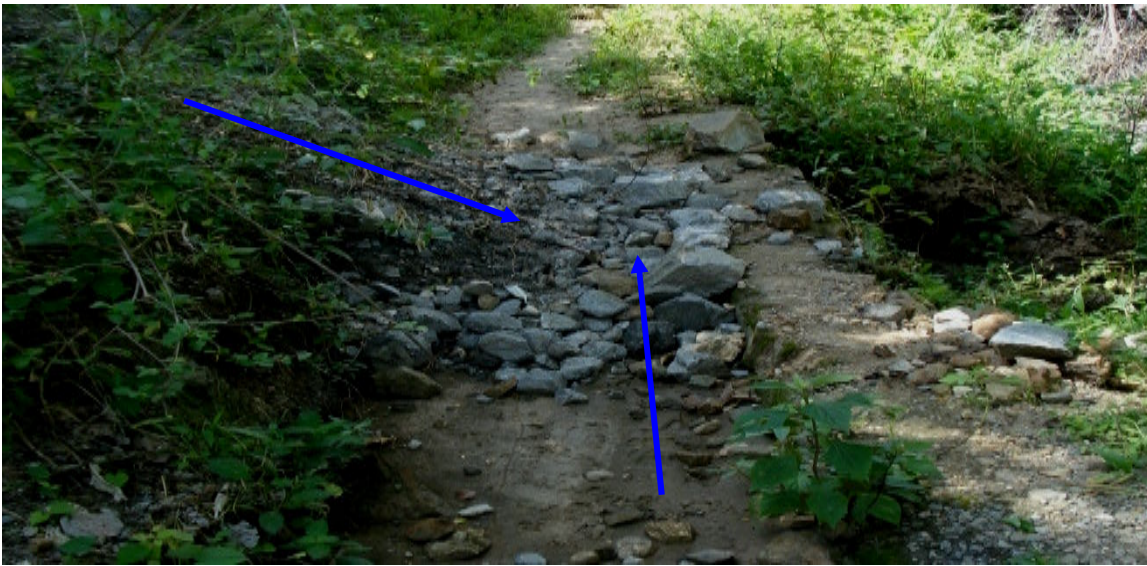
The introduction of cementing technology led to the increase in the use of stones in furrow repairs. It was noted that the increased exploitation of stones in the area has caused blockage of the furrows. The rocks often roll down from the quarries and block the furrows. Observation made at Kaptebeko furrow showed blockage of the furrow by rocks as a result of quarrying activity (Plate 4).

**Plate 4 Blockage of the Kaptebeko Furrow by Rock Falls**

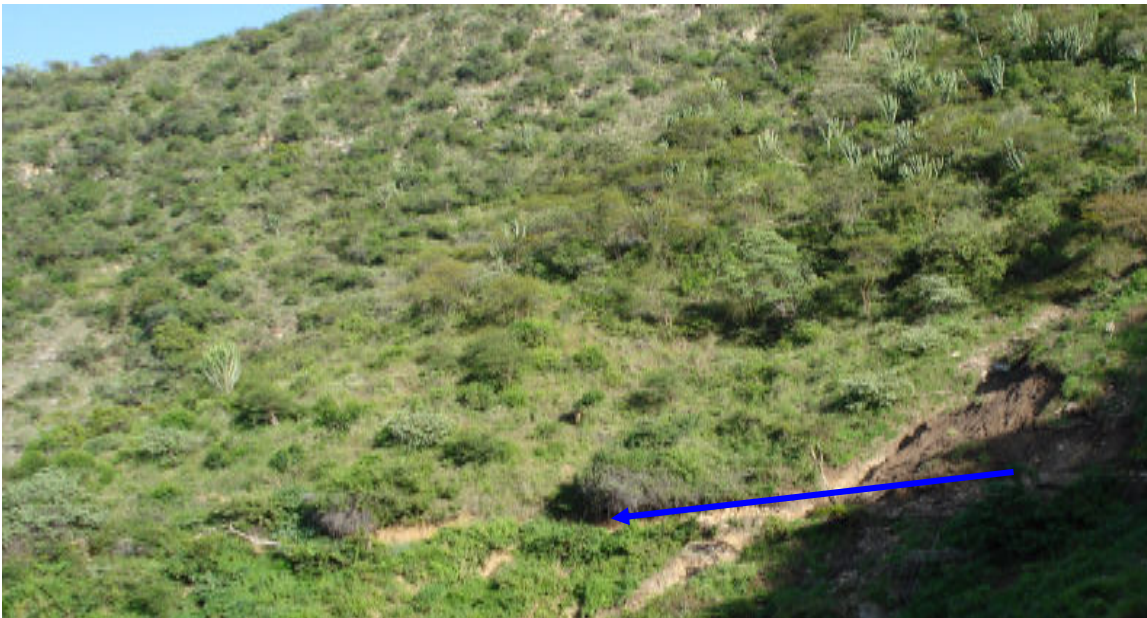
The deforestation of the escarpment has turned the area bare and exposed it to rainfall erosion which has consequently caused the breakage and siltation of the furrows. Observation made at the Kasukut furrow along the Kapchubai escarpment shows damage of the furrows by effects of breakage triggered by deforestation (Plate 5).

**Plate 5 Breakage of Kasukut Furrow in the Kapchubai Escarpment**

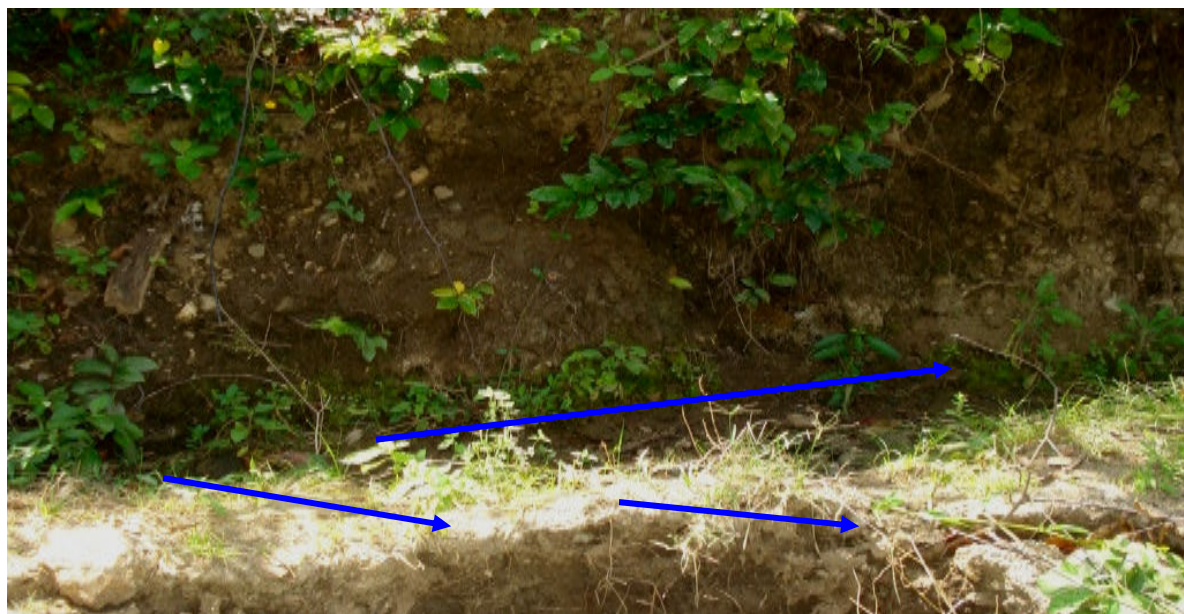
In the same area, observation made at the Kabarmwar furrow showed a total of six severely eroded areas that are attributed to deforestation of Kapchubai escarpment. The areas included Embokolion, Solion, Kiptor, Chemutuwei, Embokakanar and Leketetwo. The Embokolion area has been intensely eroded into bare rocks and is no longer holding the furrow repair.

Furrow technicians suggested drilling of the rock faces and installation of pipes in the site as a mitigation measure. 400 bags of cement were used to rehabilitate the furrow in the Embokolion area in 2001 but the material went into waste when the furrow collapsed following the heavy rains. The Chemutuwei area is bare rock with algae of about 50 metres long. Observation made at the Kabarmwar furrow in the Kiptor area in Kapchubai escarpment shows erosion of the furrow from the effects of environmental degradation (Plate 6).

**Plate 6 Erosion of Kabarmwar Furrow at Kiptor in Kapchubai Escarpment**

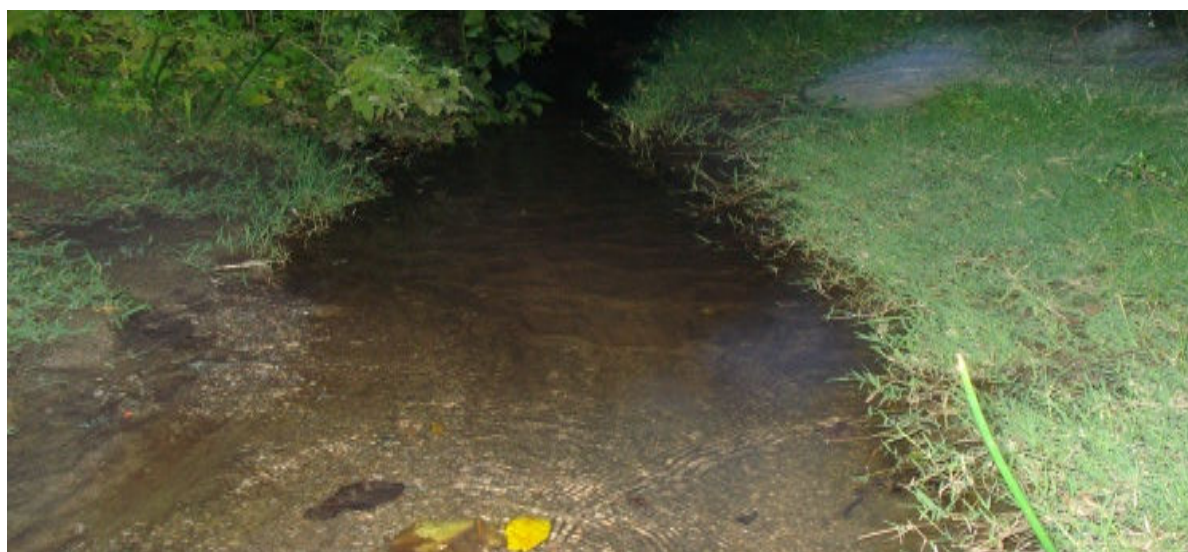
During the focus group discussions, it emerged that deforestation of the Embobut Forest in neighbouring Tirap Division is the other factor causing deterioration of the furrows. The respondents were mostly concerned about the destruction of the forest which is the main catchment for the Embobut River. The deforestation of the Embobut Forest has reduced the volume of water in the Embobut River. In the past, the water was sufficient for crop irrigation in the area. Measurement of Embobut River water, at the top above all the furrows and at the bottom below all the furrows was estimated at 1227 l/sec and 477 l/sec; respectively (Soper, 1982). Observation of the river flow at Sagat gorge shows little water that does not adequately feed eight furrows (Plate 7).

**Plate 7 Reduced Water level in the Embobot River**

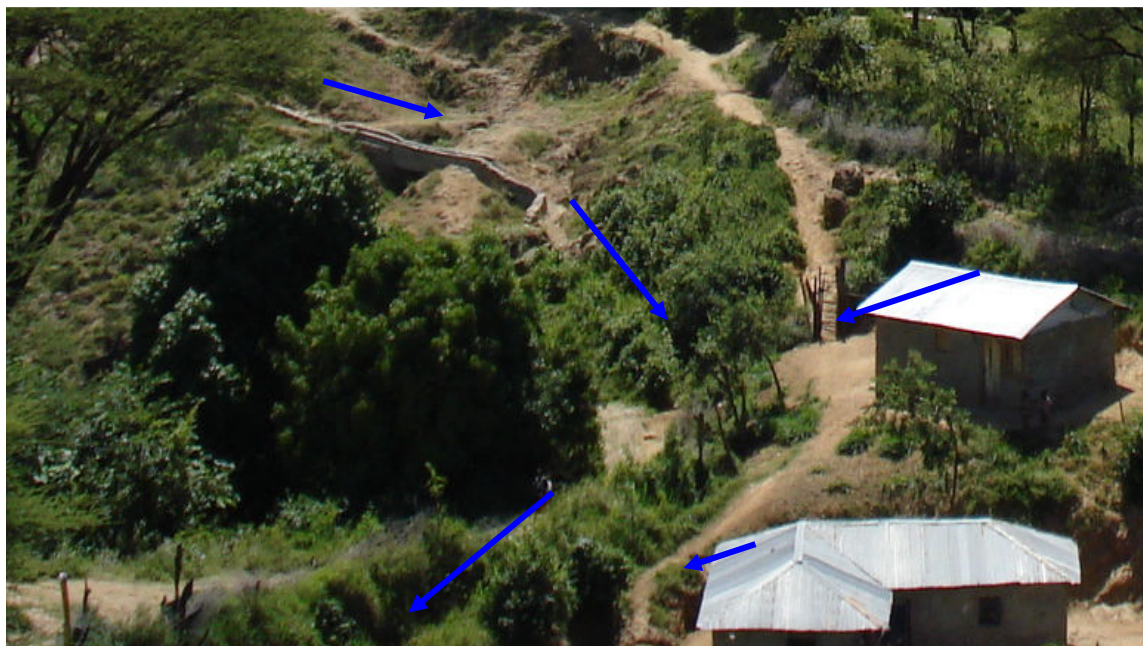
In the focused group discussions it emerged that for the last few years, the increase in population has forced people to settle near the furrows. The demographic statistics show that between 2002 and 2008, the population in Tot division increased from 17,744 to 21,787, an increase of 22.7%. In the five sub-locations studied, the population increased from 7,768 to 9,458, an increase of 21.7% (GOK:2002). The population pressure has increased settlements in the area and the conservation of the furrow areas has been affected. Observation made on the Kasukut furrow showed increased settlements near the furrow line (Plate 8).

The increased settlements along the furrow lines has caused damage in that rain water drains from the roofs add to the flows into the furrow causing huge overflows, breakage, siltation and erosion. The study found that the problem is intense in Sibow Sub-Location because of the construction of modern iron-roofed houses whose rain water collection is higher than the traditional grass thatched houses.

**Plate 8: Settlement along the Kasukut Furrow**

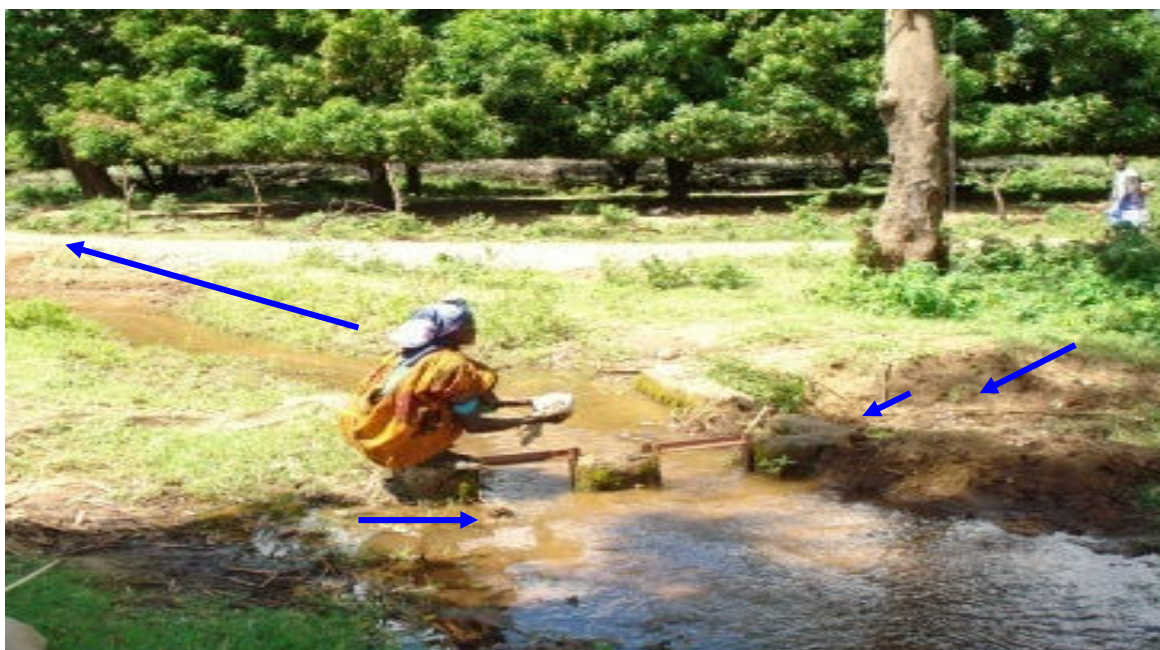
Among all the Marakwet irrigation furrows, the Kasukut furrow is highly tabooed because of sacred groves along the furrow embankments. The trees are used for performances of traditional ceremonies and have thus been conserved for many generations. Women who bathe in it are often cursed by the Kasukut elders. The culprits often experience miscarriages and infertility due to contravention of the furrow taboos. The taboos have been transformed into a clan rule and are being sensitized through the Catholic Youth Camp in the Endo Mission. In the five sub-locations studied, it was found that taboos minimises deterioration of furrows from natural causes such as erosion, siltation and leakages. The empirical reasons for not allowing women to directly use the systems is to enhance the protection of furrows and limit deterioration from erosion and tramping. The study found that furrow taboos are observed only to a small degree by the community because of culture change, for example, the influx of modern clothing and containers that require frequent washing. Observation made on the Kapsyoi, Kaptebeko and Kapsogom furrows showed women washing clothes directly from the furrows (Plate.9).

**Plate 9. A woman washes clothes directly in the Kapsyoi Furrow**

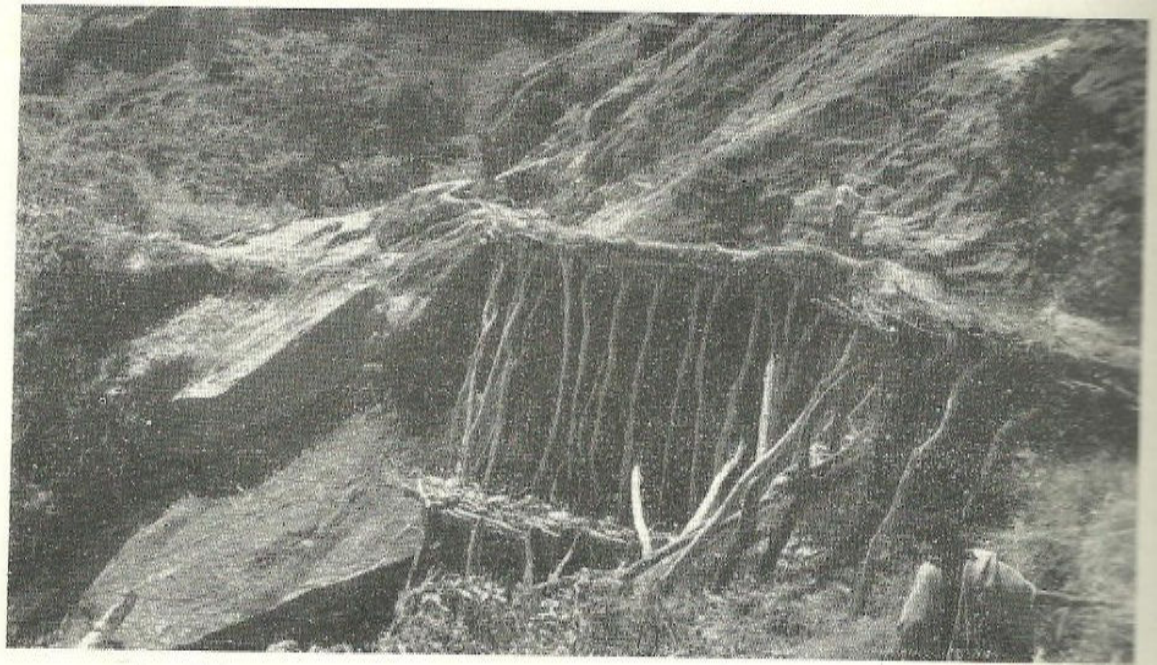
Like other indigenous irrigation systems in Eastern Africa, Mararakwet people used logs, together with grass, leaves and stumps for repair of furrow embankments and on the gullies to provide access across the escarpments and other steep areas. In the steep areas logs of 15-20 meters in diameter were used (plate 10).

It was noted that wooden materials used for construction remain buried for prolonged periods in wet environment and decay. This has weakened the furrow artifact. Scientifically, wood materials suffer drastic decay because cellulose components of cell walls undergo biological degradation. Studies show that white fungi (*Ganoderma colossum* and *phanerochaete chrysosporum*) and brown fungi (*Wolfipora cocos* and *Fomitopsis pinicola*) causes loss of starch, hollocellulose and lignin in wooden materials both on the exposed and waterlogged environments (Florian, 1977; Barbour *et al* 1981; Blanchette, 1993; Eriksson *et al.* 1990). According to the key informants, wood from *Olea chrysophylla*, *Berchemia discolors* *Ficus sycamorus* and *Acacia tortilis* tree species used in furrow construction has been infested with moulds and insects. Observation made on the Kapsogom clan furrow at Elilwo and Chepter areas showed that the wood materials used in the construction of the furrows has powdery stuff which is an indication of insect infestation a pointer to the damage of furrow artifact. In addition, the same was observed on the Kasukut clan furrow at Kong'asis area in the Kapchubai escarpment.

**Plate 10. The rehabilitated Kapsyoi furrow, 1940s**

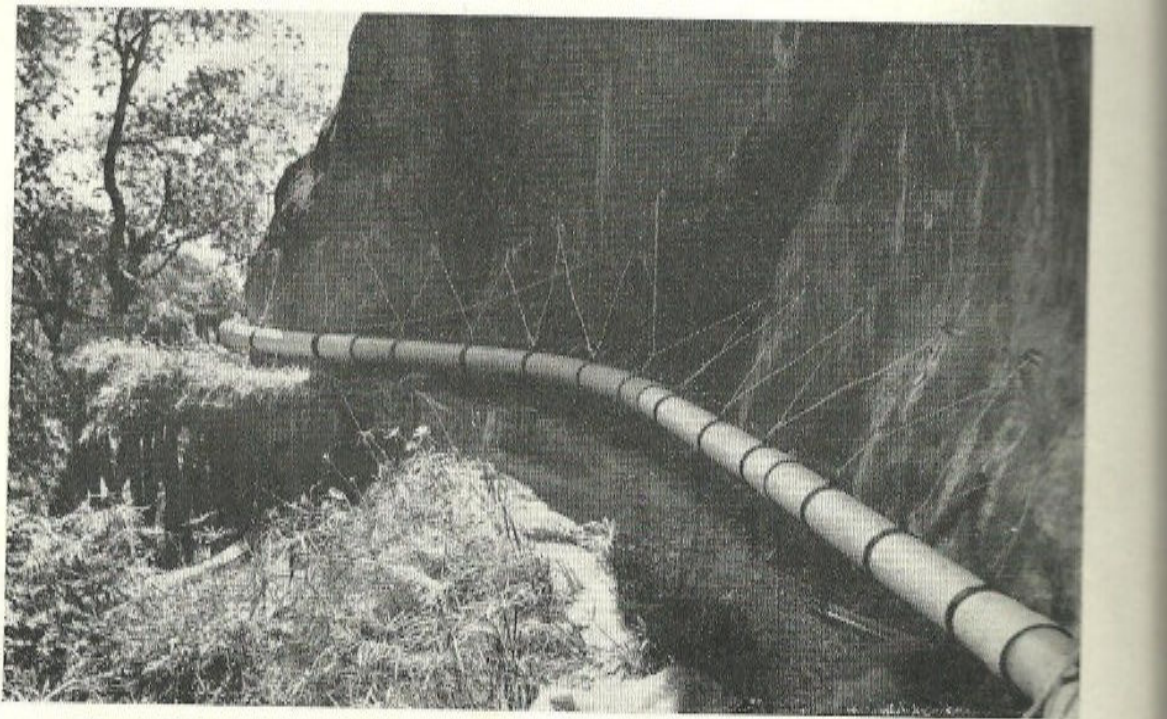
**Plate 11. The rehabilitated Kapsyoi furrow 1959**

Intervention on the decay of Marakwet furrows was first undertaken during 1950s. British colonialist introduced piping technology to restore the furrows (Plate 11). In late 1980s, the pipe was again dismantled and a concrete floor supported by stone pillars of upto 10 meters was reconstructed by the Kapsyoi clansmen ( Plate 12)

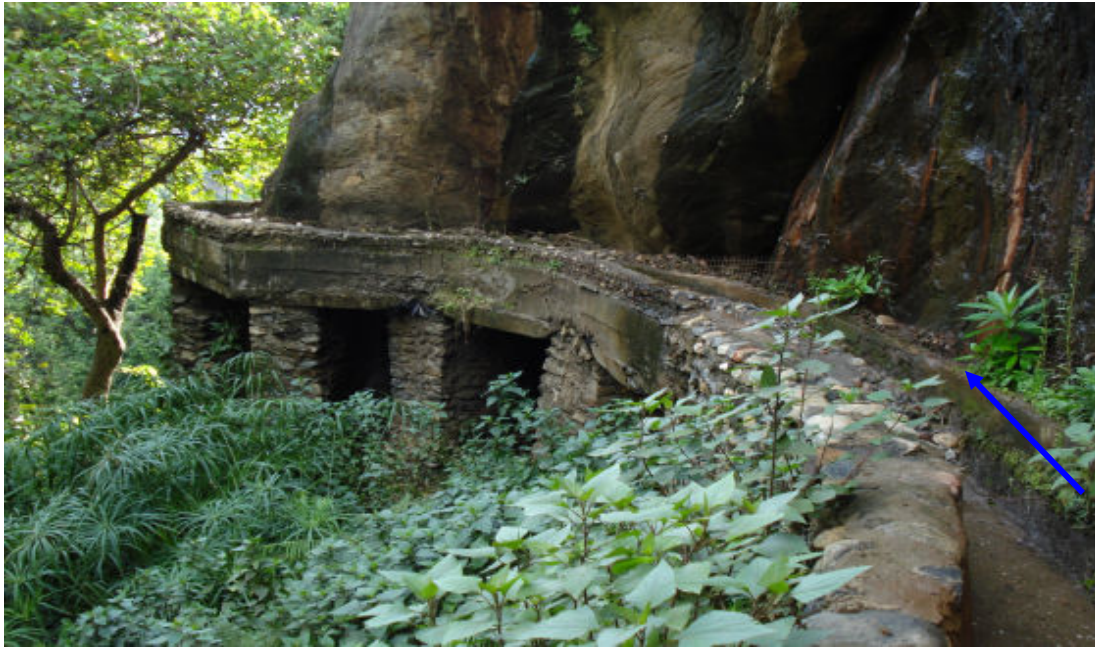
**Plate 12. The Concreted Kapsyoi Furrow at the Baon Cliff constructed in 1980s**
